## PROPERTY INSPECTION REPORT

### Pre-Handover Building Inspection

Property: Detached Residential Villa - Cyprus

Inspection Type: Pre-Handover Building Inspection

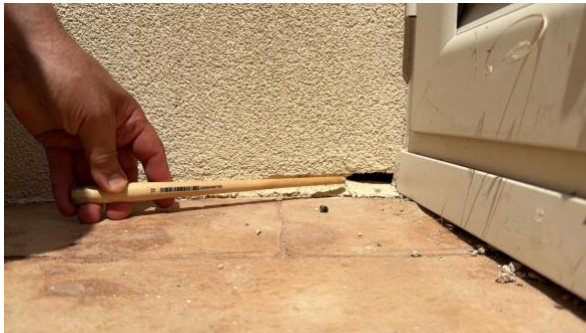
▪ **PRIORITY 2 - EXTERNAL FINISH / WATER INGRESS** | **Observation:** A pronounced open gap was present at a low-level external wall/floor junction adjacent to an external service door area. A probe could be inserted significantly into the opening. **Implication:** The open joint provides a potential route for rainwater or wash-down water to enter behind the external finish and may be associated with the deterioration visible to the corresponding internal wall. **Recommendation:** Open the defective edge locally as required, remove loose material, investigate the continuity of the void and reinstate the junction using a compatible exterior repair and weatherproof sealing system.

Figure 3. Open external junction capable of admitting water.

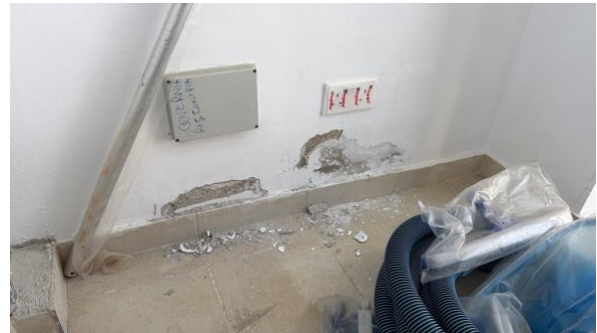
Figure 4. Internal finish deterioration on the corresponding wall.

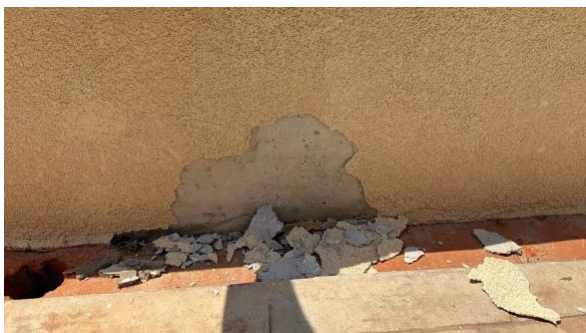
▪ **PRIORITY 2 - EXTERNAL RENDER / WORKMANSHIP** | **Observation:** Localised detachment and loss of the textured exterior render finish (graffiato) was observed at low level. **Implication:** Loss of adhesion exposes the substrate and can permit progressive deterioration where moisture reaches the interface. **Recommendation:** Remove all loose or debonded material to a sound edge, check the substrate and moisture condition, apply appropriate bonding preparation and reinstate the textured finish to match adjacent work.

Figure 5. Localized delamination of textured exterior render.

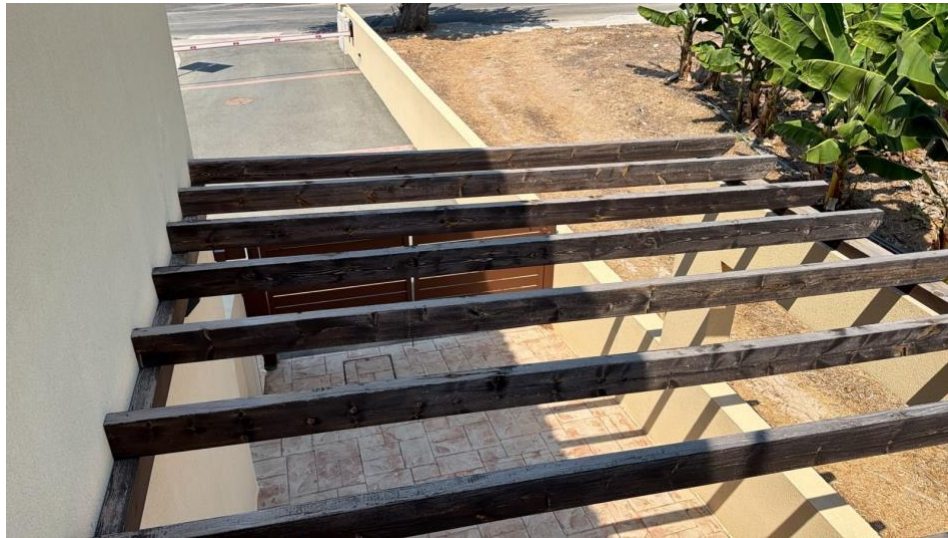
▪ **PRIORITY 2 - PERGOLA / EXTERNAL TIMBER** | **Observation:** The timber pergola finish was visibly weathered with substantial loss of the original protective stain. The rear face of adjacent pergola construction also remained unfinished. **Implication:** Weathered timber is more susceptible to UV and moisture deterioration; unfinished cementitious faces are also more exposed to water penetration and inconsistent weathering. **Recommendation:** Prepare and renew the exterior timber protection/stain and complete all unfinished external faces with the specified protective finish.

Figure 7. Weathered timber pergola requiring renewed protective finish.

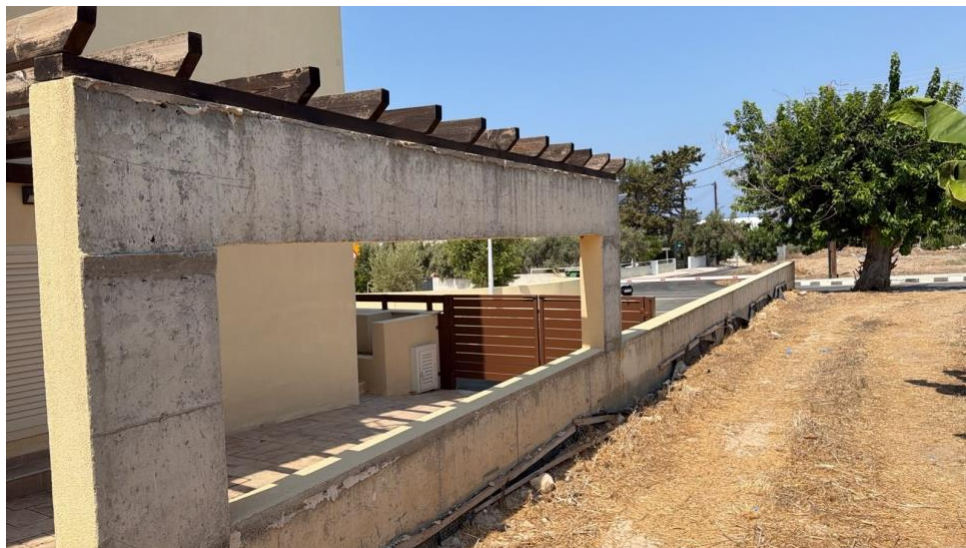
Figure 8. Unfinished exposed concrete face to the pergola support structure at the neighbouring side.

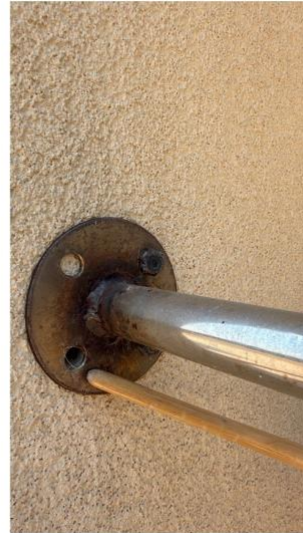
▪ **PRIORITY 2 - ROOF ACCESS / SAFETY** | **Observation:** The wall-mounted roof-access ladder fixing plates used two bolts at several locations although four fixing holes are provided. Some installed bolts were also visibly misaligned. **Implication:** Incomplete or poorly aligned anchorage can reduce the intended fixing capacity and allow movement under use. **Recommendation:** Check the installation against the ladder fixing requirements, provide the full specified anchors into sound substrate and verify stability before use.

Figure 10. Close-up of a ladder wall fixing showing incomplete bolting arrangement.

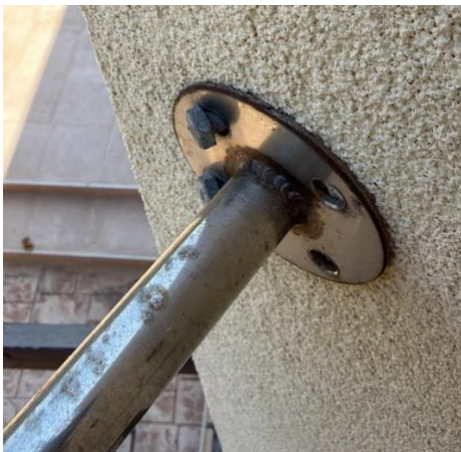
Figure 11. Further view of a roof-access ladder fixing showing incomplete anchorage.

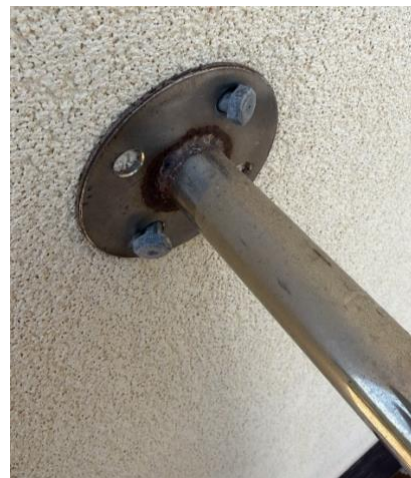
Figure 12. Roof-access ladder fixing plate with incomplete bolting.

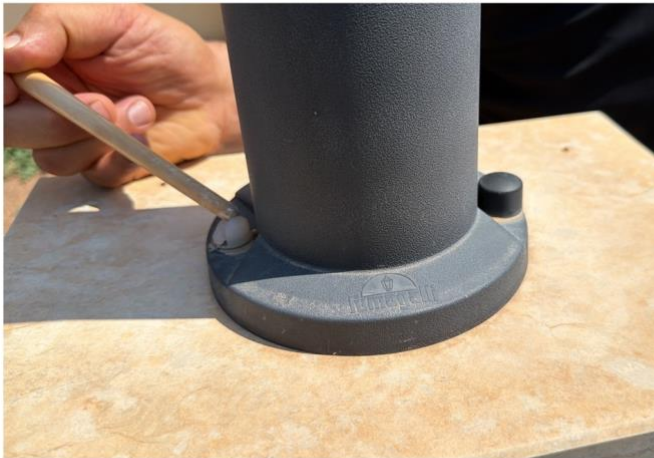
Figure 13. Missing protective screw cap at an external light fitting.

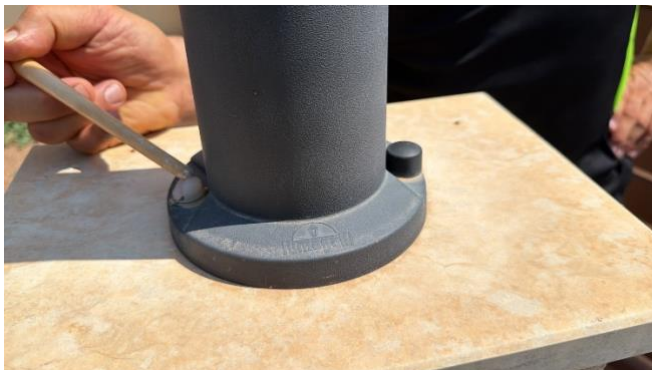
Figure 15. Further view of the missing protective screw cap at an external light fitting.

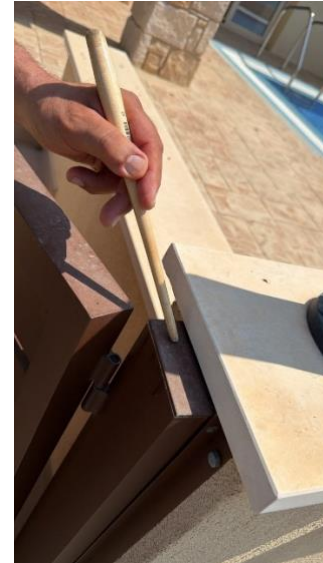
Figure 14. Missing cover to the gate finishing element.

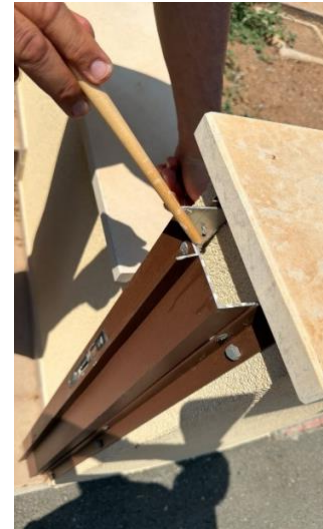
▪ **PRIORITY 3 - GATE / EXTERNAL FINISHING** | **Observation:** A visible gap was present at the gate. Local entrance and boundary finishing was also incomplete, including missing protective screw caps at the external light fittings and a missing cover to a small gate element. **Implication:** These items are principally finishing defects, but exposed fixings and open-ended elements can deteriorate prematurely when left exposed to weather. **Recommendation:** Adjust the gate alignment as required and install the missing proprietary caps so that all external fixings and open-ended components are properly protected and neatly finished.

Figure 16. Open gap at the vehicle gate and boundary finishing junction.

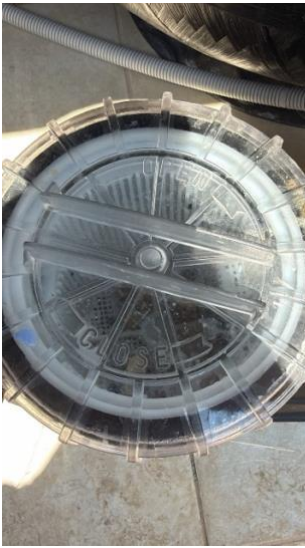
▪ **PRIORITY 3 - POOL DRAINAGE / MAINTENANCE** | **Observation:** Open drainage points around the pool area require suitable covers and the pool filter contained visible debris. The pool plant and associated pipework were visually checked and no active leakage was noted at the time of inspection. **Implication:** Unprotected drainage openings can admit leaves and debris and may become obstructed, while a dirty filter can reduce circulation efficiency. **Recommendation:** Install appropriate drainage covers, clean the filter and complete routine servicing of the pool system before handover.

Figure 17. Debris visible within the pool filter basket.

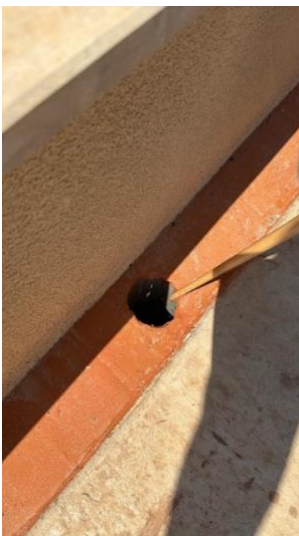
Figure 19. Uncovered drainage opening within the pool area.

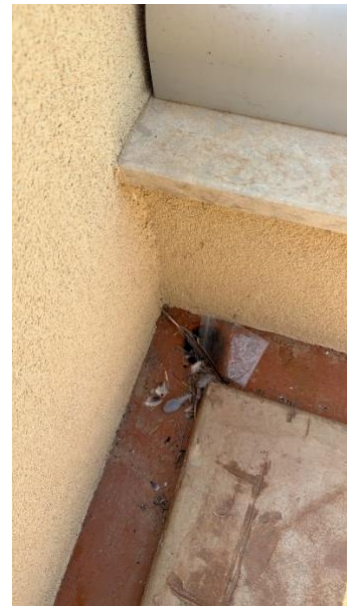
Figure 20. Further uncovered pool-area drainage opening with debris accumulation.

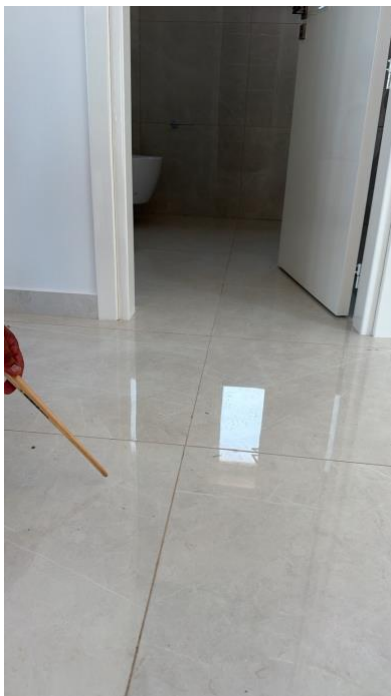
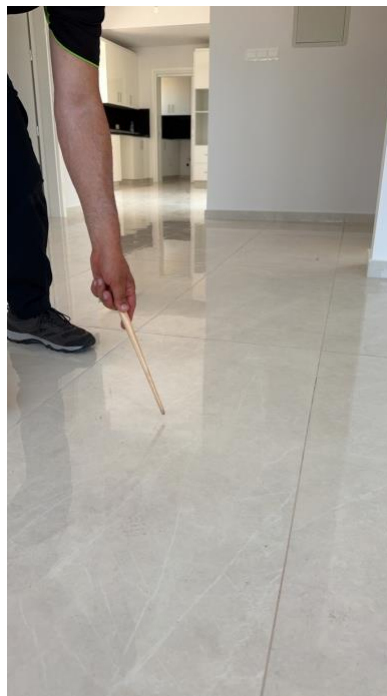
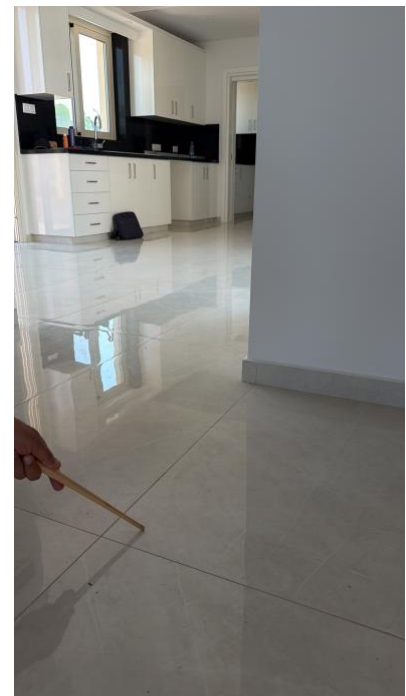
▪ **PRIORITY 2 - TILING / WORKMANSHIP** | **Observation:** Several ground-floor tiles, particularly in front of the guest WC and toward the fireplace area, produced a distinctly hollow response during tap testing. **Implication:** A hollow response commonly indicates incomplete adhesive coverage or loss of bond beneath the tile. If left uncorrected, affected tiles may be more susceptible to cracking, movement or debonding under service. **Recommendation:** Map the affected locations by systematic tap testing and carefully lift and re-bed or replace deficient tiles using full and continuous adhesive coverage in accordance with the tile adhesive manufacturer requirements.

Figure 22. Tap testing of ground-floor tiles where hollow response was identified.

Figure 23. Additional ground-floor tile location checked by tap testing.

Figure 24. Further affected ground-floor tiled area identified during inspection.

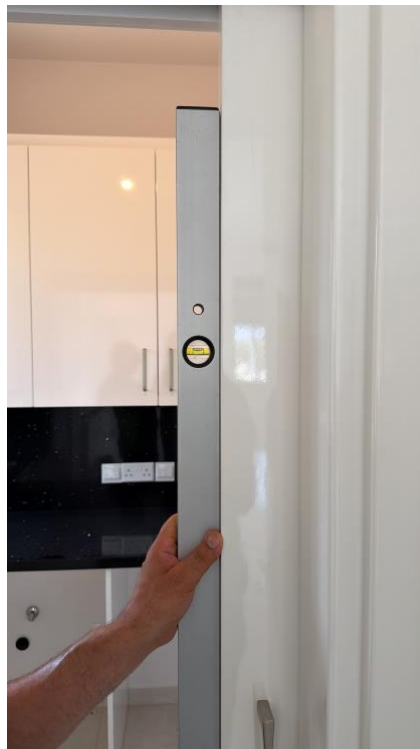
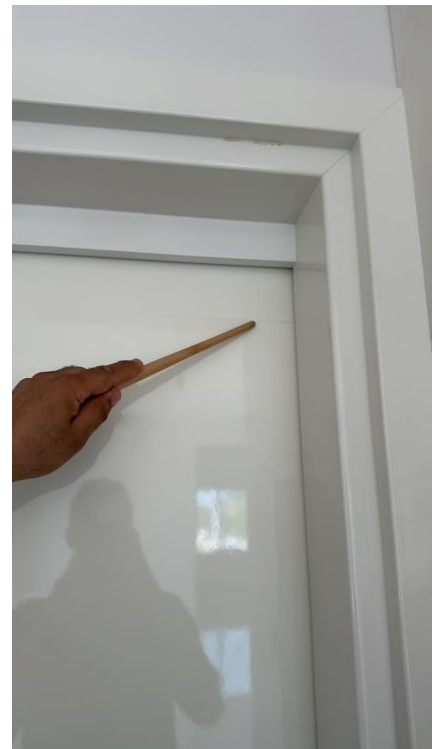
▪ **PRIORITY 2 - SLIDING DOOR / ALIGNMENT** | **Observation:** The internal kitchen sliding door was not operating freely through its full travel and visible contact marks were present at the upper door interface. Alignment checks indicated that the frame requires adjustment. **Implication:** Continued rubbing may damage the finish and can progressively impair smooth operation or prevent the door from closing correctly. **Recommendation:** Check the track, rollers, guides and frame alignment, adjust the sliding leaf and confirm smooth unobstructed travel through the full opening and closing cycle.

Figure 26. Alignment check to the sliding-door frame.

Figure 27. Contact marking at the upper sliding-door interface.

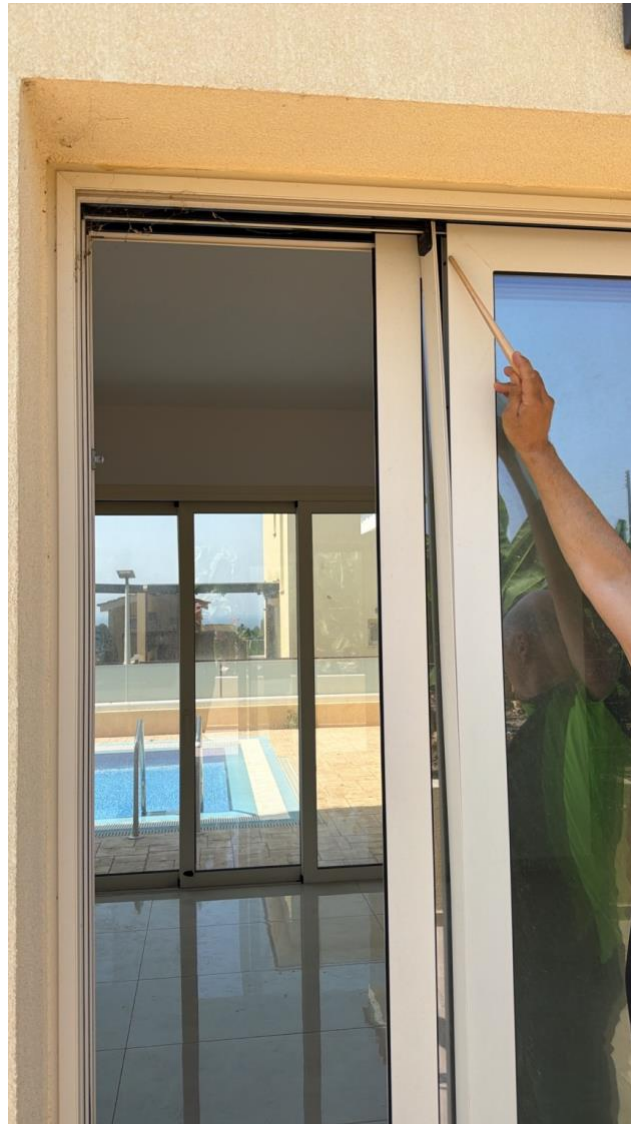
▪ **PRIORITY 2 - EXTERNAL SLIDING DOOR FRAME / INSTALLATION** | **Observation:** An open and inadequately finished junction was observed at the upper corner of the aluminium sliding-door frame serving the kitchen-to-backyard access. The frame appears locally separated, leaving a visible opening at the head junction. **Implication:** The incomplete frame junction may affect the weather-tightness and overall finishing of the door installation and could permit air or moisture ingress if the external sealing system is discontinuous. **Recommendation:** The Aluminum technician should inspect the frame assembly, correctly secure and align the affected components, and reinstate the junction sealing using an appropriate compatible weather-resistant sealant. The door should subsequently be checked for smooth operation and effective closure.

Figure 28. Open junction at the upper corner of the kitchen-to-backyard aluminium sliding-door frame.

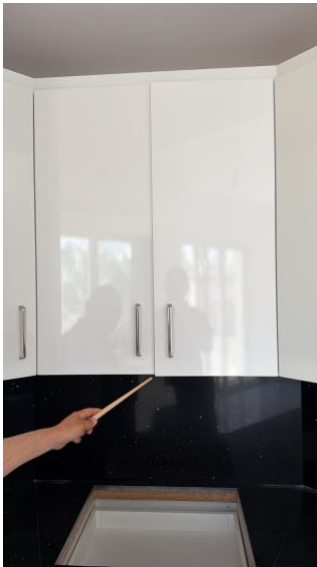
▪ **PRIORITY 3 - KITCHEN JOINERY / FINISH** | **Observation:** Localized misalignment was observed between kitchen cabinet fronts and adjacent joinery elements. Yellow staining was also visible along the rear junction of the cabinet below the sink. **Implication:** Cabinet misalignment affects the quality of the finished installation. The staining may be associated with previous moisture exposure, construction residue or prolonged humidity; the visual inspection alone does not establish the precise cause. **Recommendation:** Realign and adjust affected doors to provide even margins. Check the under-sink cabinet and adjoining plumbing for active or historic leakage, clean the affected surfaces and replace any board that shows swelling, softening or loss of integrity.

Figure 29. Misalignment between adjacent kitchen cabinet fronts.

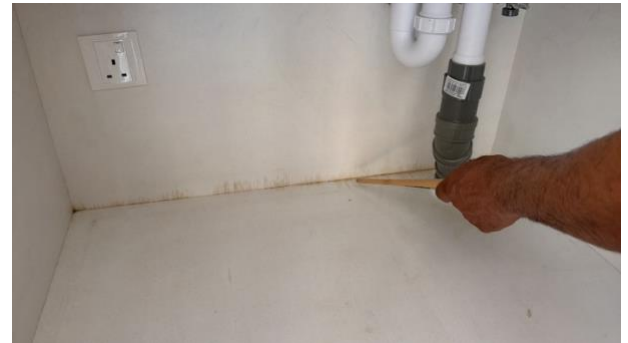
Figure 31. Yellow staining at the under-sink cabinet junction.

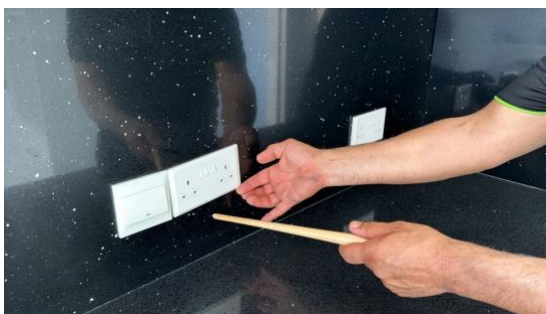
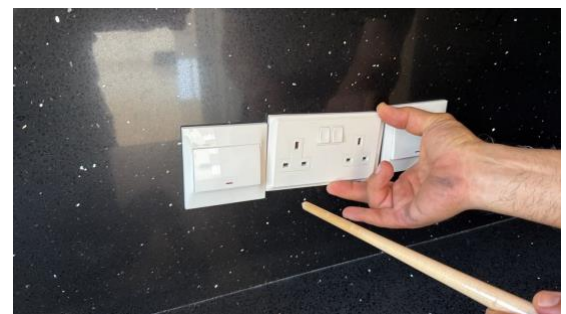
▪ **PRIORITY 2 - ELECTRICAL ACCESSORIES / SAFETY** | **Observation:** Several kitchen switches and socket outlets were loose and could be moved away from the wall finish. **Implication:** Loose accessories are below an acceptable handover standard and may place mechanical strain on wiring or expose gaps at the back box. **Recommendation:** Have a qualified electrician isolate the circuits, secure and level all affected accessories and function-test them afterwards.

Figure 32. Loose kitchen electrical socket showing movement from the wall finish.

Figure 33. Further kitchen switch requiring secure fixing.

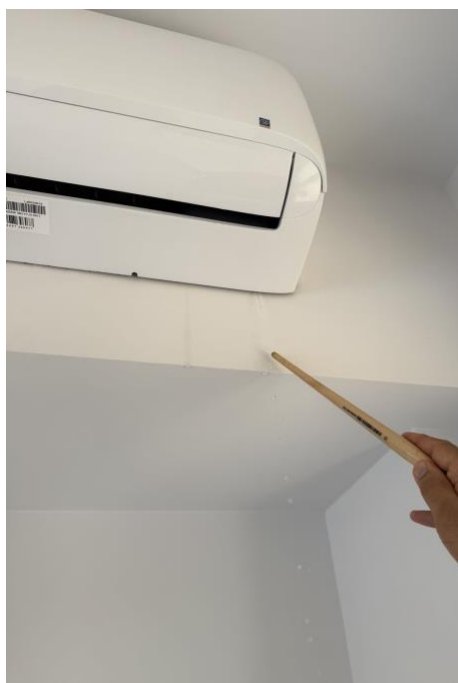
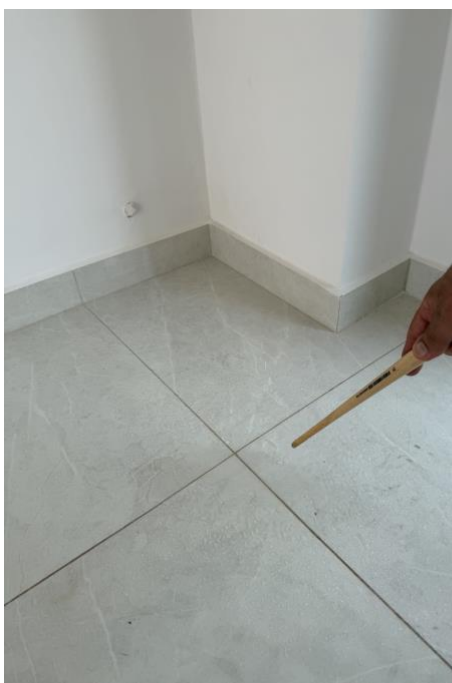
▪ **PRIORITY 2 - AIR CONDITIONING / DRAINAGE** | **Observation:** Water leakage was observed from ground-floor split air-conditioning indoor units, including the kitchen unit and the indoor unit on the wall adjacent to the fireplace. Water was visible below the units and on the adjacent floor during the inspection. **Implication:** The condition is consistent with restricted or blocked condensate drainage, although the final cause should be confirmed by the HVAC contractor. Continued leakage can stain or deteriorate paintwork, finishes and nearby joinery and may create local slip hazards. **Recommendation:** Service the affected units, clean and flush the condensate trays and drain lines, verify continuous fall and sound connections, and operate each unit under cooling conditions to confirm unrestricted discharge without internal leakage.

Figure 34. Water leakage visible below a ground-floor split air-conditioning indoor unit.

Figure 35. Residual water on the ground-floor finish associated with condensate leakage.

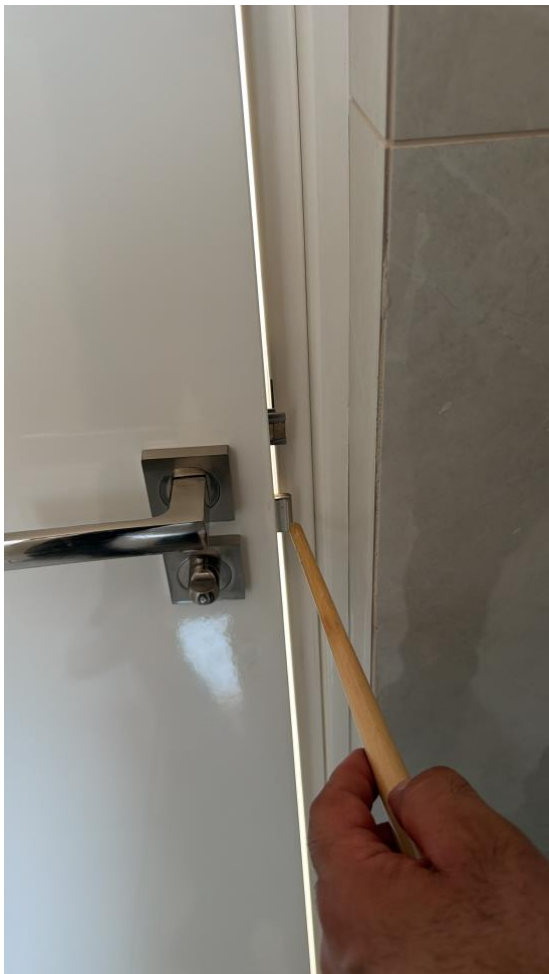
▪ **PRIORITY 3 - INTERNAL DOORS / HARDWARE** | **Observation:** The ground-floor guest WC door did not lock correctly and the intended door-stop fixing arrangement was incomplete. **Implication:** The door cannot perform as intended and may contact adjacent wall or tiled finishes during normal use. **Recommendation:** Adjust the door leaf, hinges, latch and strike plate so the door closes and locks correctly, and install or securely reinstate the appropriate door stop fixing.

Figure 37. Guest WC door hardware requiring adjustment and completion.

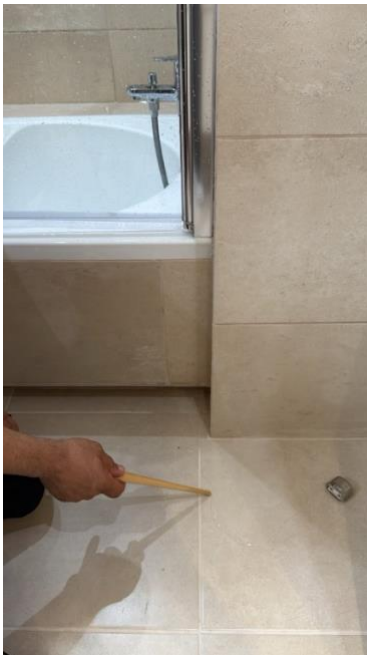
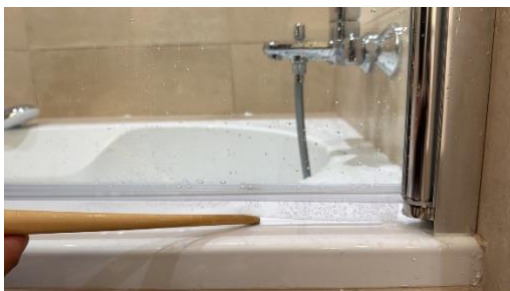
▪ **PRIORITY 2 - BATHROOM / WATER CONTAINMENT** | **Observation:** Water escaped from the shared bathroom bath/shower enclosure at the junction between the glazed screen and the bath edge during testing. **Implication:** Inadequate containment can allow repeated wetting of adjacent floor finishes and junctions. **Recommendation:** Adjust and reseal the bath interface as required and retest under normal shower conditions.

Figure 39. Water visible on the floor adjacent to the shared-bathroom bath/shower enclosure after testing.

Figure 40. Water at shared-bathroom screen junction.

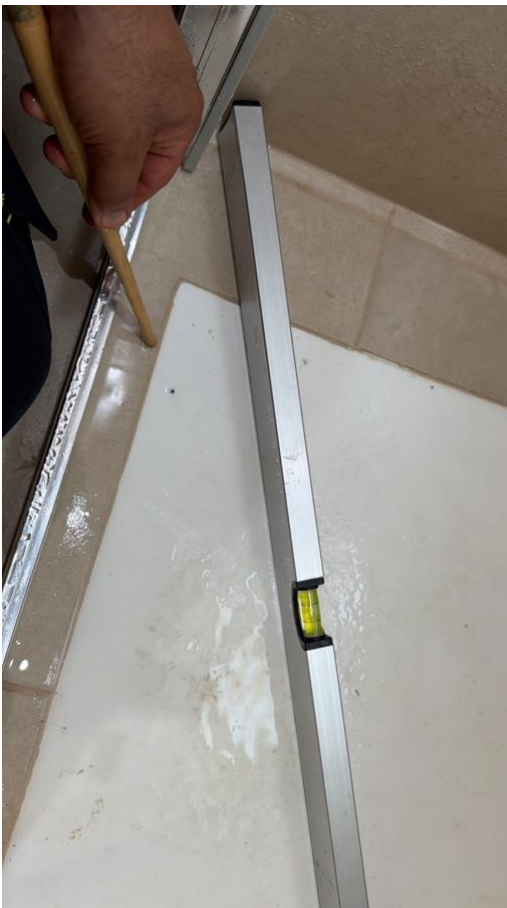
▪ **PRIORITY 3 - BATHROOM FLOORS / DRAINAGE** | **Observation:** The master-bathroom shower floor area was checked for local falls. The drainage arrangement was generally serviceable; however, the finished surface was not uniformly graded and minor residual water may remain locally around the tiled base edge. **Implication:** Localized ponding can leave water standing after use and may contribute to staining or deterioration of joints over time. **Recommendation:** Confirm drainage performance during final commissioning and locally correct any areas where persistent ponding remains.

Figure 42. Level check to the master-bathroom shower floor finish.

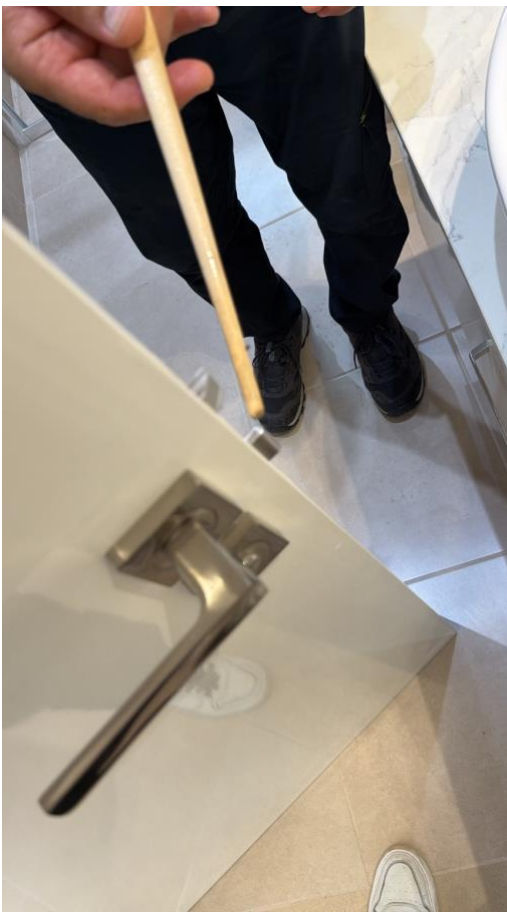
▪ **PRIORITY 2 - DOORS / FUNCTIONAL** | **Observation:** The master-bathroom door did not engage and lock reliably when closed. **Implication:** Incorrect lock adjustment or door alignment can prevent reliable closing and locking and may damage the door finishes. **Recommendation:** Adjust the master-bathroom lock to achieve smooth, reliable operation.

Figure 44. Master-bathroom door/lock requiring adjustment.

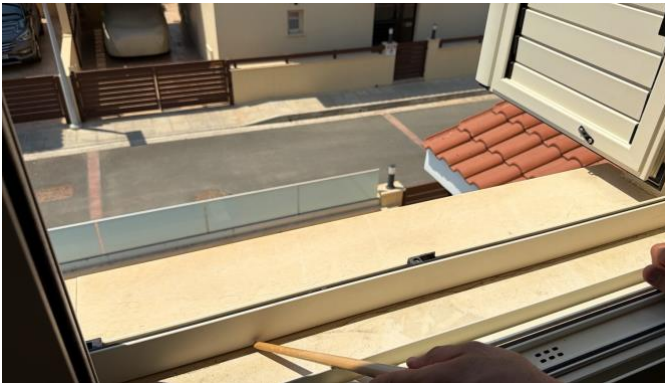
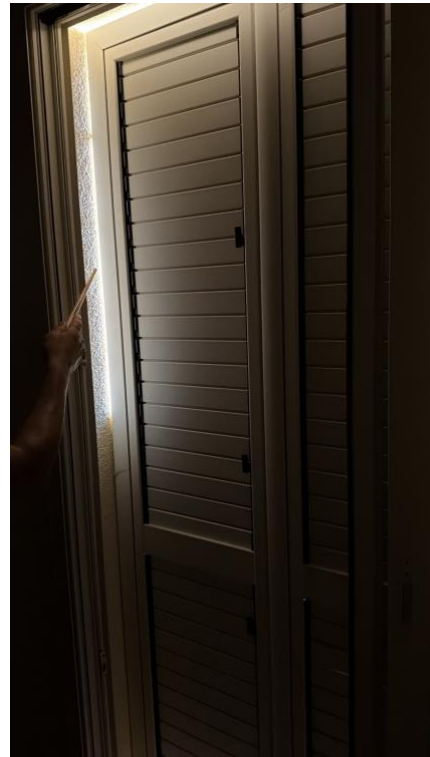
▪ **PRIORITY 2 - WINDOW / SHUTTER FRAME SEALING** | **Observation:** Incomplete perimeter sealing was identified at first-floor shutter-frame interfaces. At the middle bedroom, the lower frame junction was not adequately sealed, creating a potential route for rainwater ingress. At another side junction located in the third Bedroom, visible daylight could be seen through the frame perimeter, confirming an open gap. **Implication:** Discontinuous perimeter sealing may permit rainwater, air and dust penetration and can lead to deterioration of adjacent finishes. **Recommendation:** Clean and prepare the affected junctions and apply a continuous compatible exterior-grade weatherproof sealant to the lower and side frame interfaces, then verify the completed perimeter seal.

Figure 46. Middle-bedroom shutter frame with incomplete sealing at the lower junction.

Figure 47. Visible daylight through an open side junction at the shutter-frame perimeter.

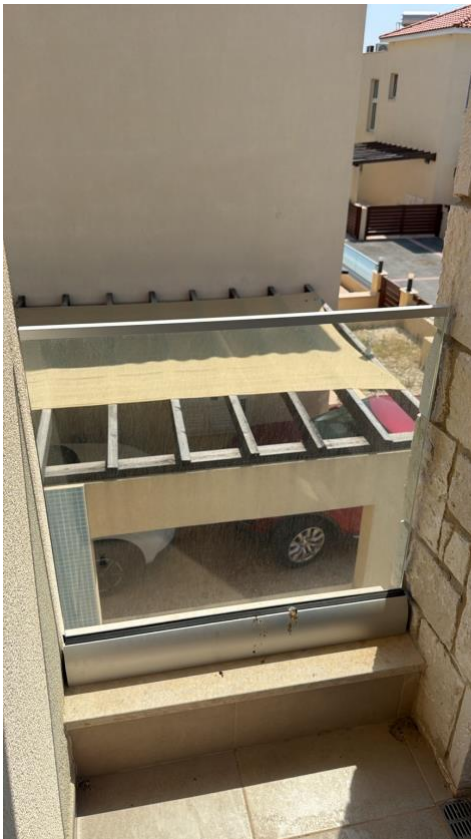
- **PRIORITY 2 - BALCONY BALUSTRADE / SAFETY** | **Observation:** Movement was identified at the glass balcony balustrade during manual checking. **Implication:** A balustrade is a safety-critical element and should remain adequately stable at its supports and fixing system. **Recommendation:** Have the specialist installer inspect the base channel and all associated fixings, tighten or replace components as required, and verify satisfactory stability before occupation.

Figure 48. Glass balcony balustrade checked for stability during the inspection.

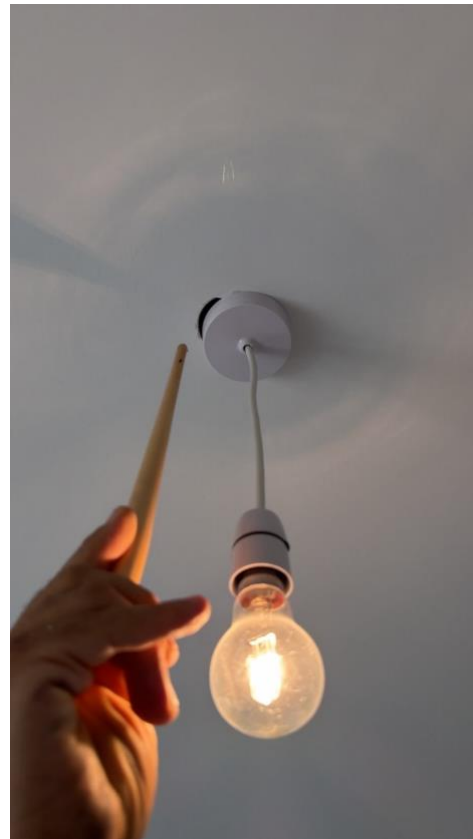
- **PRIORITY 3 - LIGHTING / FINISHING** | **Observation:** A visible gap remained around a first-floor ceiling light fitting. **Implication:** If the installed fitting is the final fixture, the surrounding ceiling penetration remains incompletely finished. **Recommendation:** Confirm the final luminaire size and arrangement; if no larger cover is to be installed, make good and neatly finish the surrounding ceiling opening.

Figure 49. Gap around the first-floor ceiling light fitting.

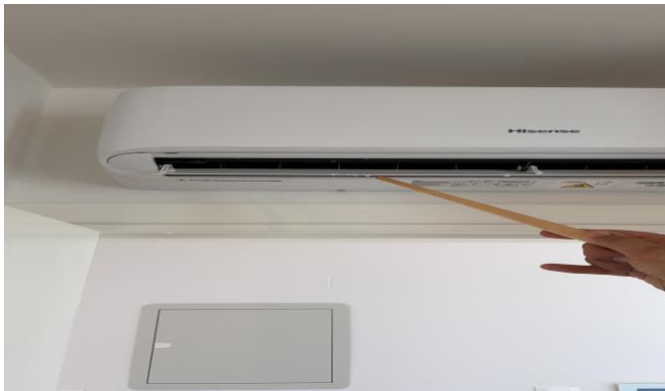
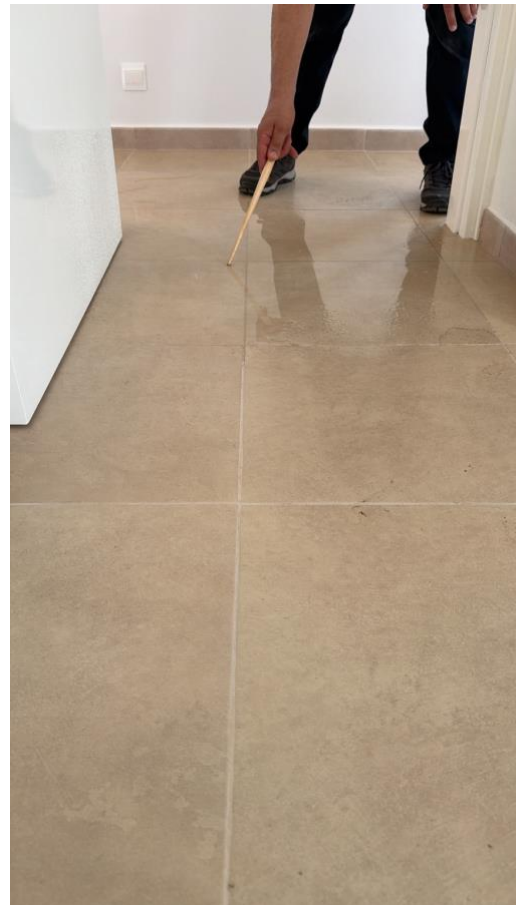
• **PRIORITY 2 - AIR CONDITIONING / DRAINAGE** | **Observation:** During testing, the air-conditioning unit serving the middle (second) bedroom discharged condensate water internally onto the finished floor, indicating restricted, blocked or otherwise defective condensate drainage. **Implication:** Continued internal condensate discharge can damage floor/wall finishes and fitted furniture and may promote moisture-related deterioration. **Recommendation:** Inspect and rectify the condensate drain line, confirm adequate fall and unrestricted discharge to the intended drainage point, and retest the unit under cooling operation.

Figure 50. Middle-bedroom air-conditioning unit associated with the condensate drainage defect.

Figure 51. Condensate water discharged internally onto the middle-bedroom floor during testing.

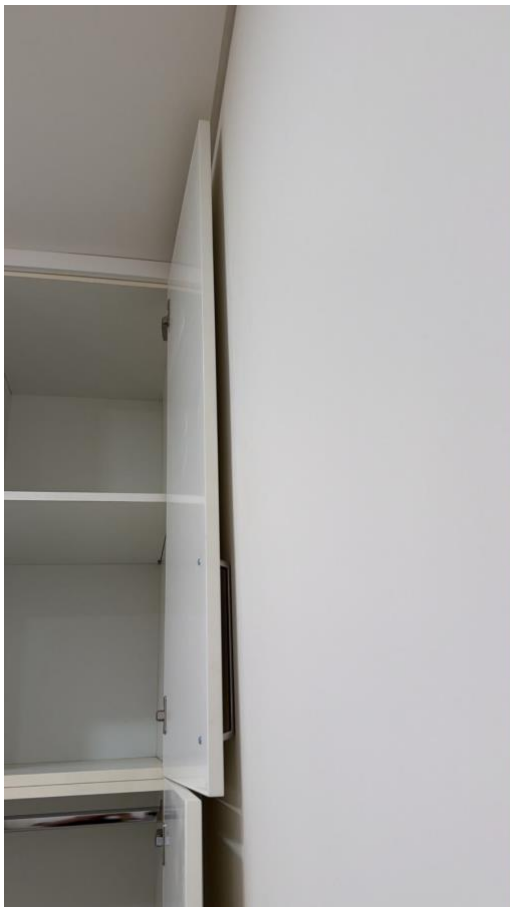
- **PRIORITY 3 - WARDROBE / JOINERY** | **Observation:** An upper wardrobe door contacts the adjacent wall when fully opened.  
**Implication:** Repeated contact may mark the wall finish and place unnecessary stress on the door edge and hinges.  
**Recommendation:** Adjust the opening angle and install a suitable stopper to prevent contact with the wall.

Figure 52. Wardrobe door with insufficient clearance to the adjacent wall.

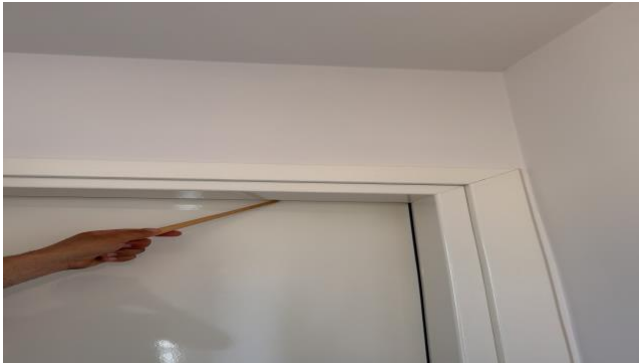
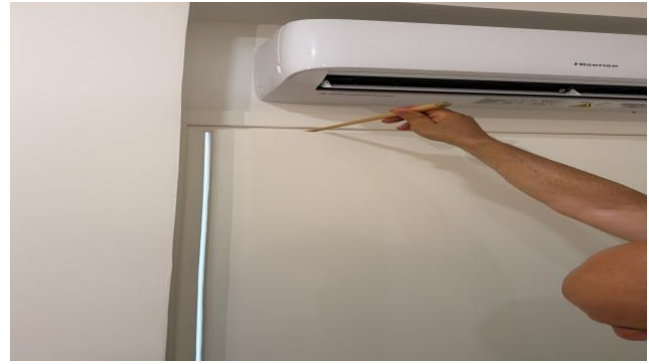
▪ **PRIORITY 3 - BEDROOM DOOR / ALIGNMENT** | **Observation:** The third bedroom door contacts the upper part of the frame when closing and does not close freely. **Implication:** Continued contact may damage the door and frame finishes and may prevent correct latching. **Recommendation:** Realign or rehang the door and adjust the hinges clearances as required to achieve smooth closing without contact.

Figure 54. Third-bedroom door contacting the upper frame during closing.

Figure 55. Further view of the third-bedroom door/frame interference.

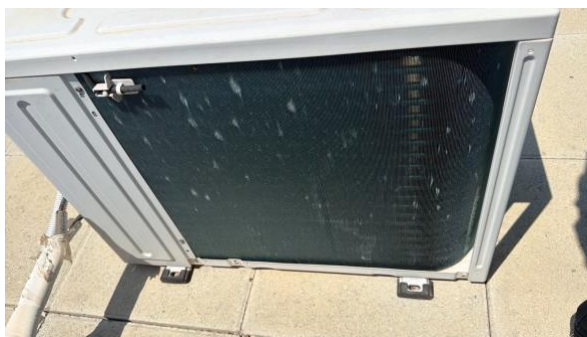
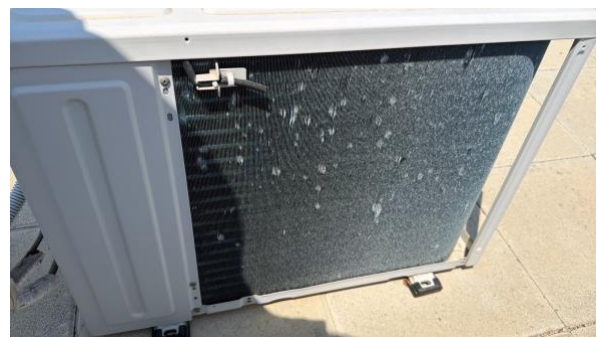
▪ **PRIORITY 2 - AIR CONDITIONING / CONDENSER COILS** | **Observation:** Several outdoor condenser coils showed bent fins. **Implication:** Bent fins reduce effective airflow through the heat exchanger and, if extensive, may reduce efficiency. **Recommendation:** Have the HVAC contractor inspect and carefully straighten repairable fins with the appropriate tool and confirm normal airflow and operation.

Figure 56. Localized damage to condenser coil fins.

Figure 57. Further condenser coil fin damage.

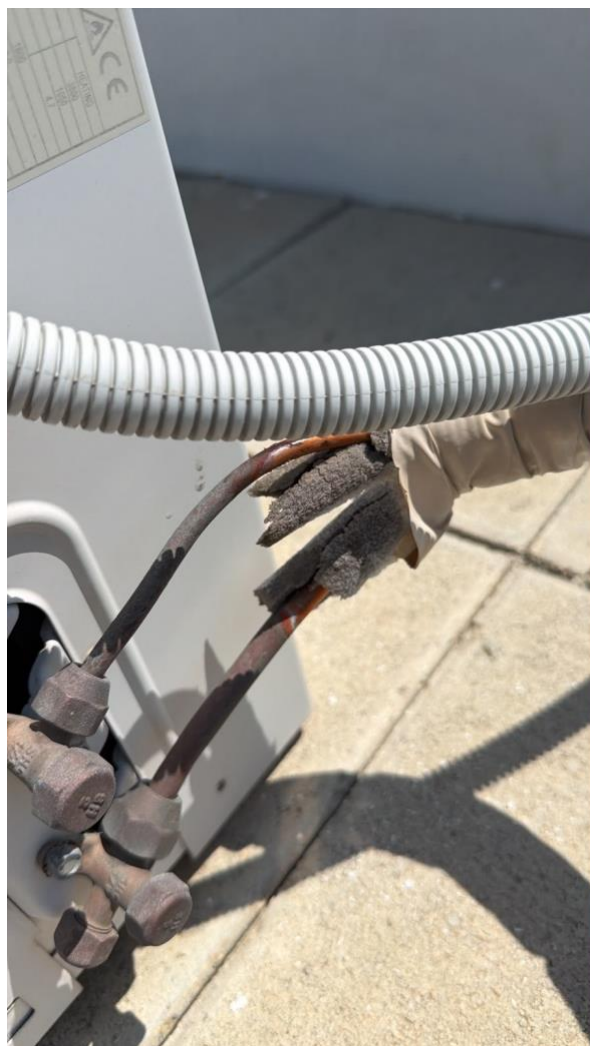
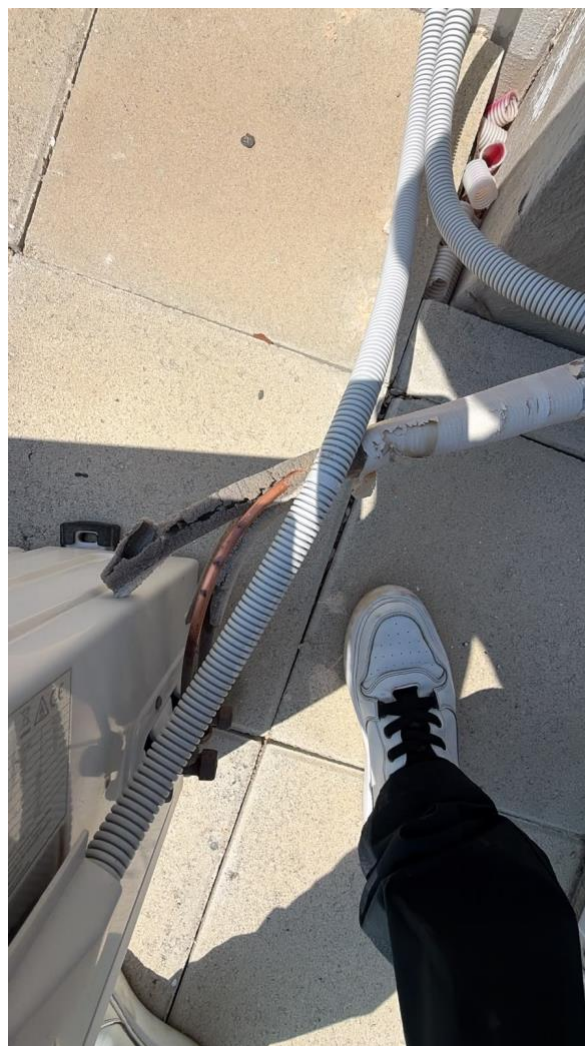
▪ **PRIORITY 2 - AIR CONDITIONING / PIPE INSULATION** | **Observation:** Exposed refrigerant copper-pipe insulation was split, deteriorated or poorly wrapped, with copper visible in places. **Implication:** Loss of insulation increases thermal loss, can promote condensation and accelerates weathering of the installation. **Recommendation:** Replace damaged insulation with suitable closed-cell UV-resistant insulation, seal all joints and protect exposed sections.

Figure 58. Deteriorated refrigerant-line insulation.

Figure 59. Exposed copper where insulation has deteriorated.

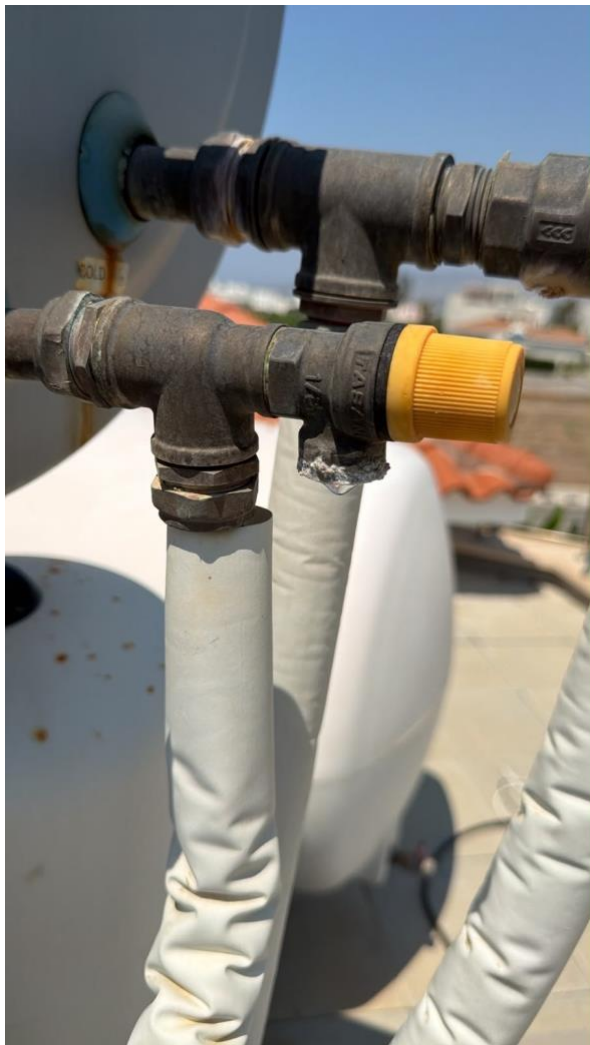
▪ **PRIORITY 2 - SOLAR HOT WATER / PLUMBING** | **Observation:** A minor active drip was visible at a valve/fitting associated with the rooftop solar hot-water installation. **Implication:** A continuous minor leak can cause water loss, mineral deposits and corrosion and

Figure 60. Visible droplet at the solar hot-water valve fitting.

may worsen over time. **Recommendation:** Identify the leaking valve, reseal or replace the affected fitting and pressure-test after repair.
