## PROPERTY INSPECTION REPORT

### Pre-Handover Building Inspection

Property: Detached Residential Villa - Cyprus

Inspection Type: Pre-Handover Building Inspection

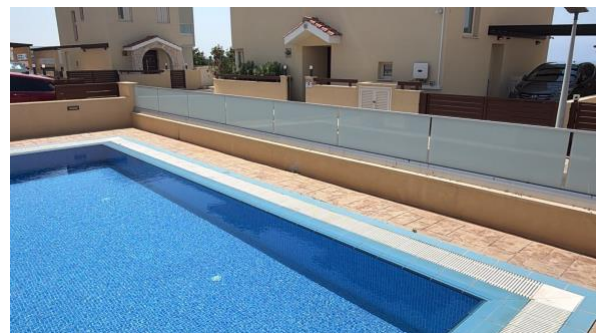
Figure 6. Pool and adjacent external area.

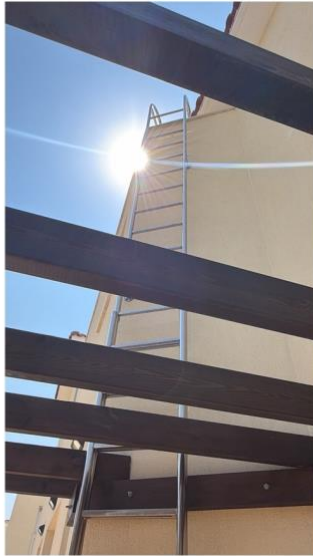
▪ **PRIORITY 2 - ROOF ACCESS / SAFETY** | **Observation:** The wall-mounted roof-access ladder fixing plates used two bolts at several locations although four fixing holes are provided. Some installed bolts were also visibly misaligned. **Implication:** Incomplete or poorly aligned anchorage can reduce the intended fixing capacity and allow movement under use. **Recommendation:** Check the installation against the ladder fixing requirements, provide the full specified anchors into sound substrate and verify stability before use.

Figure 9. Overall view of the wall-mounted roof-access ladder.

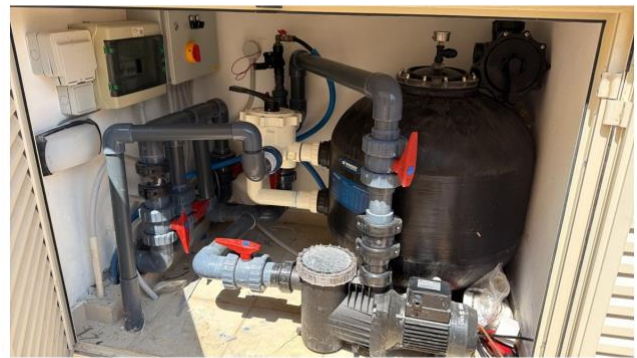
▪ **PRIORITY 3 - POOL DRAINAGE / MAINTENANCE** | **Observation:** Open drainage points around the pool area require suitable covers and the pool filter contained visible debris. The pool plant and associated pipework were visually checked and no active leakage was noted at the time of inspection. **Implication:** Unprotected drainage openings can admit leaves and debris and may become obstructed, while a dirty filter can reduce circulation efficiency. **Recommendation:** Install appropriate drainage covers, clean the filter and complete routine servicing of the pool system before handover.

Figure 18. Overall view of the pool plant and associated pipework.

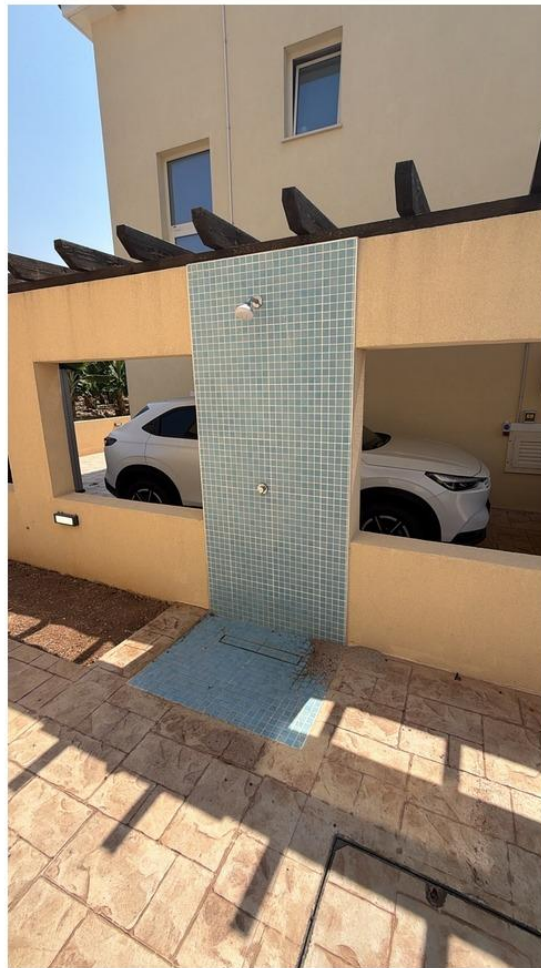
The outdoor shower was tested during the inspection and operated satisfactorily. The local floor finish appeared to provide an appropriate fall toward the drainage area, with no obvious water migration beyond the shower zone observed during the test.

Figure 21. Outdoor pool shower tested during the inspection.

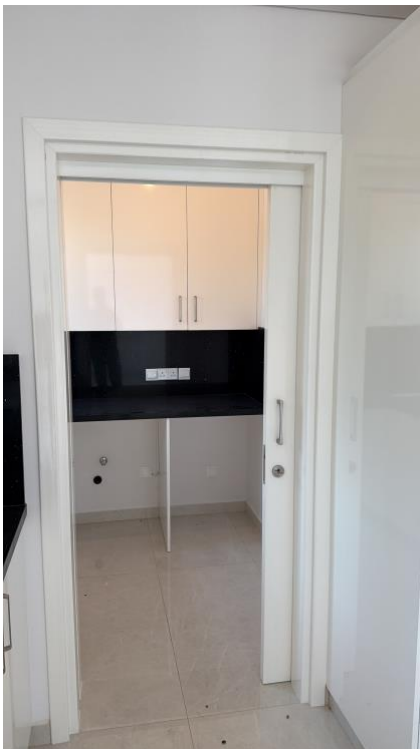
▪ **PRIORITY 2 - SLIDING DOOR / ALIGNMENT** | **Observation:** The internal kitchen sliding door was not operating freely through its full travel and visible contact marks were present at the upper door interface. Alignment checks indicated that the frame requires adjustment. **Implication:** Continued rubbing may damage the finish and can progressively impair smooth operation or prevent the door from closing correctly. **Recommendation:** Check the track, rollers, guides and frame alignment, adjust the sliding leaf and confirm smooth unobstructed travel through the full opening and closing cycle.

Figure 25. Overall view of the kitchen internal sliding-door opening.

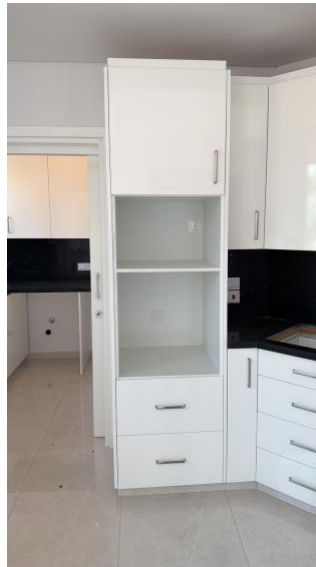
▪ **PRIORITY 3 - KITCHEN JOINERY / FINISH** | **Observation:** Localized misalignment was observed between kitchen cabinet fronts and adjacent joinery elements. Yellow staining was also visible along the rear junction of the cabinet below the sink. **Implication:** Cabinet misalignment affects the quality of the finished installation. The staining may be associated with previous moisture exposure, construction residue or prolonged humidity; the visual inspection alone does not establish the precise cause. **Recommendation:** Realign and adjust affected doors to provide even margins. Check the under-sink cabinet and adjoining plumbing for active or historic leakage, clean the affected surfaces and replace any board that shows swelling, softening or loss of integrity.

Figure 30. Overall view of the kitchen joinery installation.

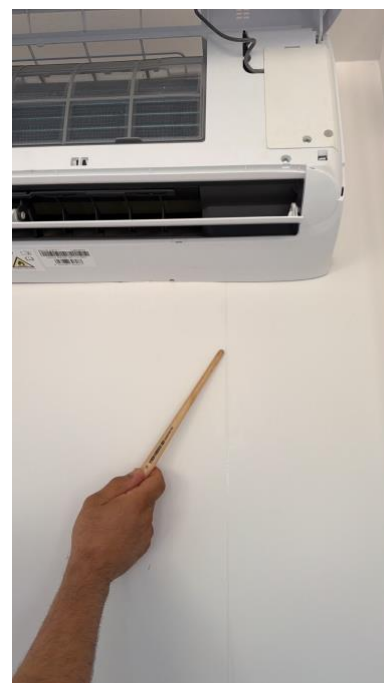
▪ **PRIORITY 2 - AIR CONDITIONING / DRAINAGE** | **Observation:** Water leakage was observed from ground-floor split air-conditioning indoor units, including the kitchen unit and the indoor unit on the wall adjacent to the fireplace. Water was visible below the units and on the adjacent floor during the inspection. **Implication:** The condition is consistent with restricted or blocked condensate drainage, although the final cause should be confirmed by the HVAC contractor. Continued leakage can stain or deteriorate paintwork, finishes and nearby joinery and may create local slip hazards. **Recommendation:** Service the affected units, clean and flush the condensate trays and drain lines, verify continuous fall and sound connections, and operate each unit under cooling conditions to confirm unrestricted discharge without internal leakage.

Figure 36. Additional ground-floor split air-conditioning unit inspected for condensate-drainage leakage.

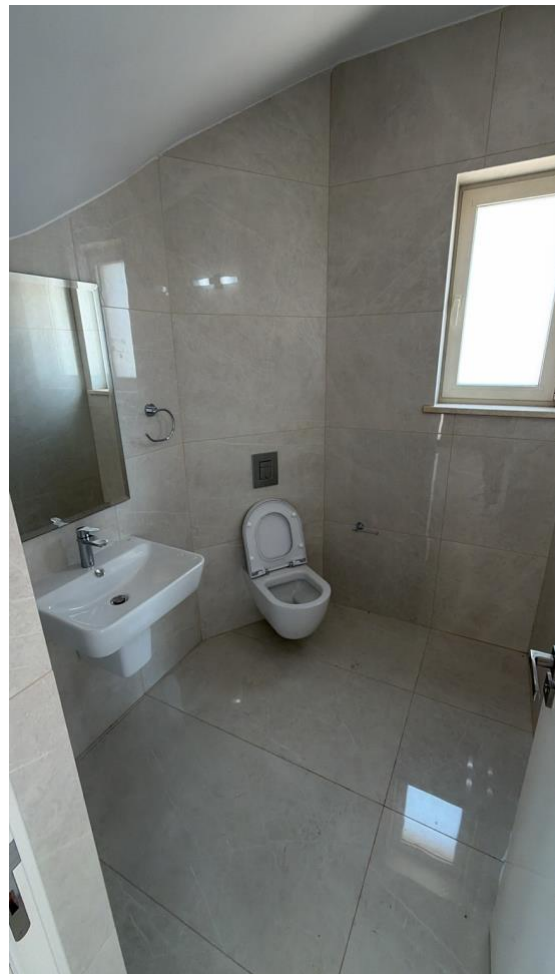
▪ **PRIORITY 3 - INTERNAL DOORS / HARDWARE** | **Observation:** The ground-floor guest WC door did not lock correctly and the intended door-stop fixing arrangement was incomplete. **Implication:** The door cannot perform as intended and may contact adjacent wall or tiled finishes during normal use. **Recommendation:** Adjust the door leaf, hinges, latch and strike plate so the door closes and locks correctly, and install or securely reinstate the appropriate door stop fixing.

Figure 38. Overall view of the ground-floor guest WC and affected internal door.

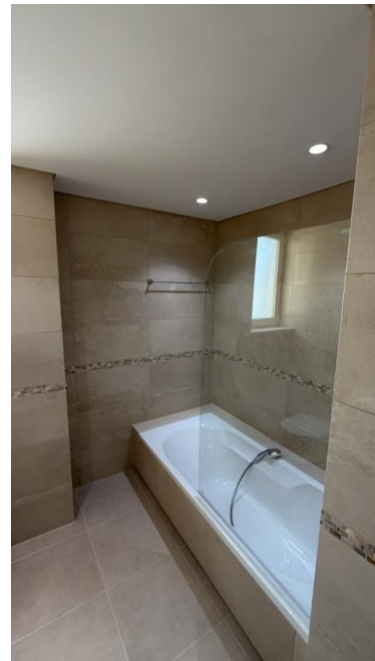
▪ **PRIORITY 2 - BATHROOM / WATER CONTAINMENT** | **Observation:** Water escaped from the shared bathroom bath/shower enclosure at the junction between the glazed screen and the bath edge during testing. **Implication:** Inadequate containment can allow repeated wetting of adjacent floor finishes and junctions. **Recommendation:** Adjust and reseal the bath interface as required and retest under normal shower conditions.

Figure 41. Shared bathroom enclosure and screen arrangement.

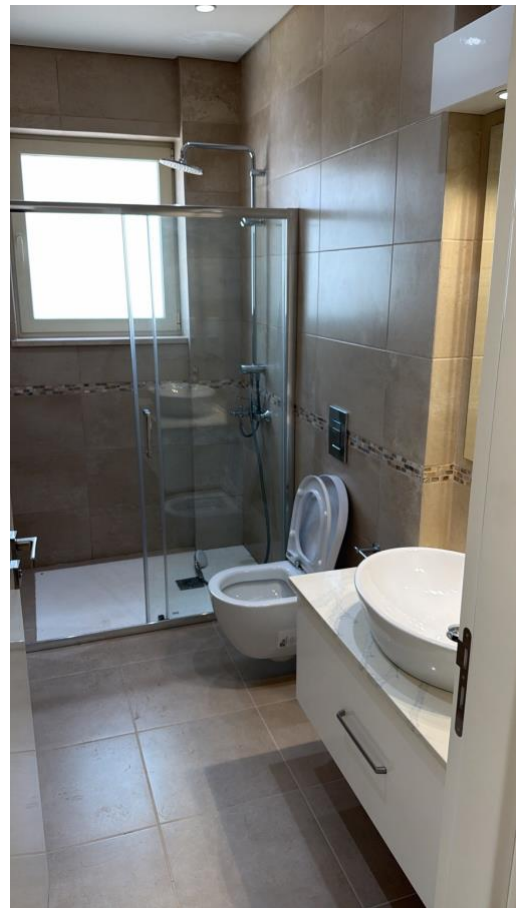
▪ **PRIORITY 3 - BATHROOM FLOORS / DRAINAGE** | **Observation:** The master-bathroom shower floor area was checked for local falls. The drainage arrangement was generally serviceable; however, the finished surface was not uniformly graded and minor residual water may remain locally around the tiled base edge. **Implication:** Localized ponding can leave water standing after use and may contribute to staining or deterioration of joints over time. **Recommendation:** Confirm drainage performance during final commissioning and locally correct any areas where persistent ponding remains.

Figure 43. Overall view of the master-bathroom shower area inspected for drainage and falls.

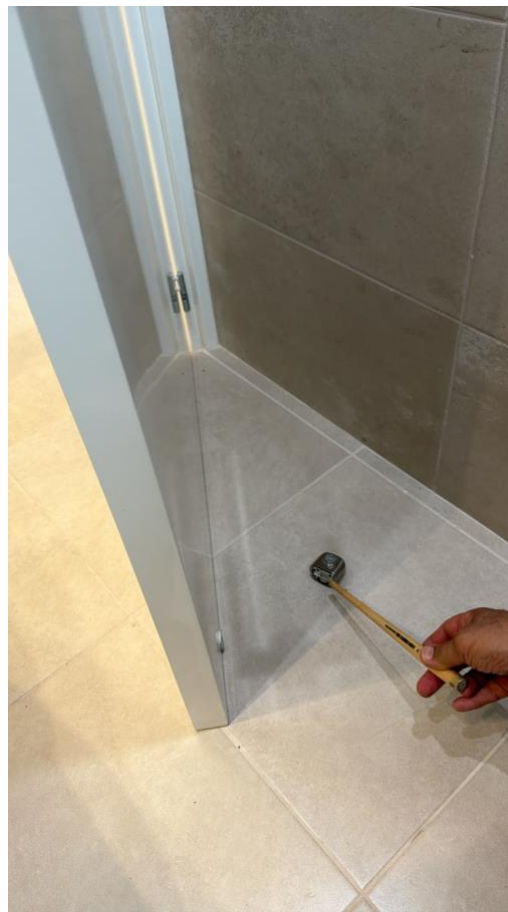
▪ **PRIORITY 2 - DOORS / FUNCTIONAL** | **Observation:** The master-bathroom door did not engage and lock reliably when closed. **Implication:** Incorrect lock adjustment or door alignment can prevent reliable closing and locking and may damage the door finishes. **Recommendation:** Adjust the master-bathroom lock to achieve smooth, reliable operation.

Figure 45. Floor-mounted door stop adjacent to the master-bathroom door.

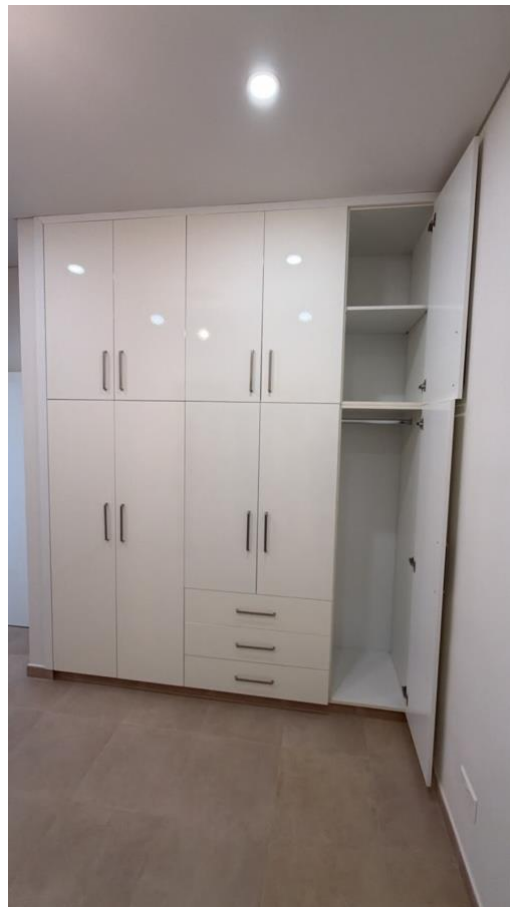
- **PRIORITY 3 - WARDROBE / JOINERY** | **Observation:** An upper wardrobe door contacts the adjacent wall when fully opened.  
**Implication:** Repeated contact may mark the wall finish and place unnecessary stress on the door edge and hinges.  
**Recommendation:** Adjust the opening angle and install a suitable stopper to prevent contact with the wall.

Figure 53. Overall view of the wardrobe installation and affected door.

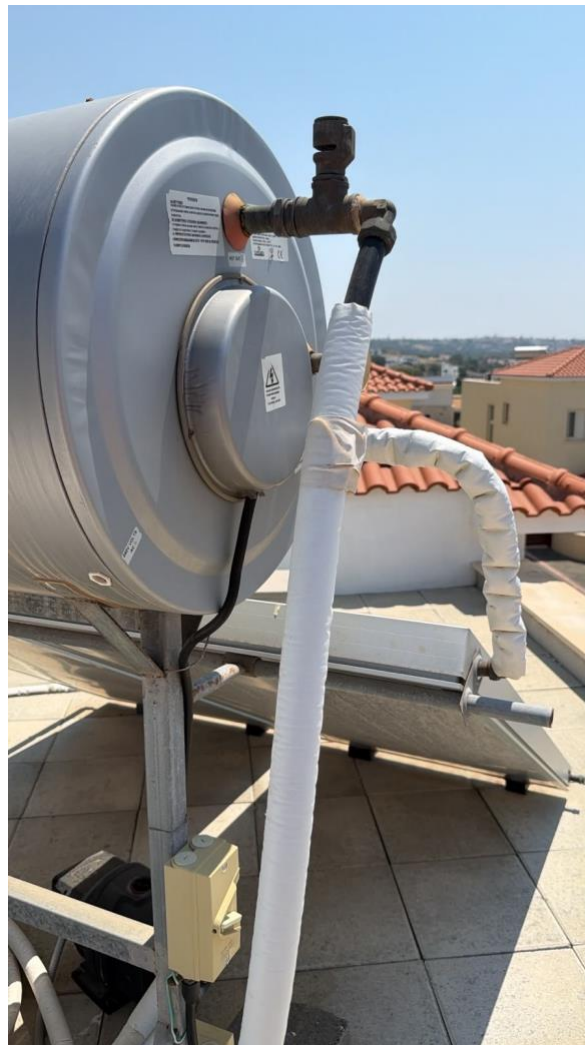
Figure 61. Roof-mounted solar hot-water equipment.

The solar storage tank was otherwise reported to be functioning at the time of inspection. Any corrective work should be completed by a competent plumbing technician and rechecked after the system returns to normal operating temperature and pressure.

may worsen over time. **Recommendation:** Identify the leaking valve, reseal or replace the affected fitting and pressure-test after repair.

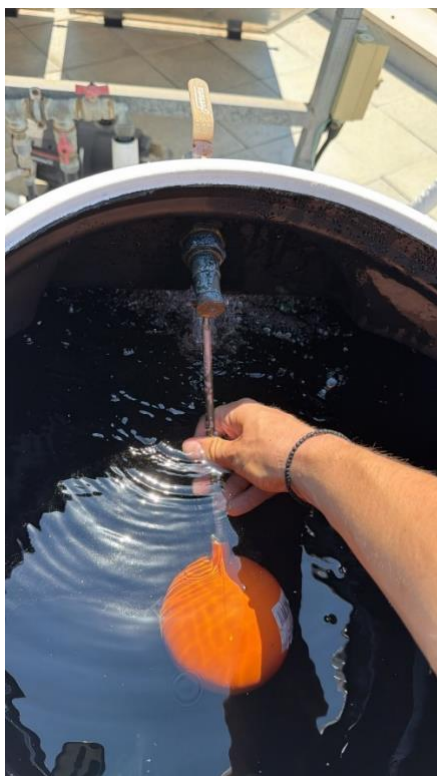
Figure 62. Water-storage tank internal float-valve check. condensers and water-storage tank.
